Connector Rod Fracture & Failure Analysis in Airplane Engine of 1979 Cessna-152 N49681

MATE - 450 - 01 / 02
Professor Ryan T. Smith

California Polytechnic State University, San Luis Obispo
Department of Materials Science & Engineering

December 8, 2021

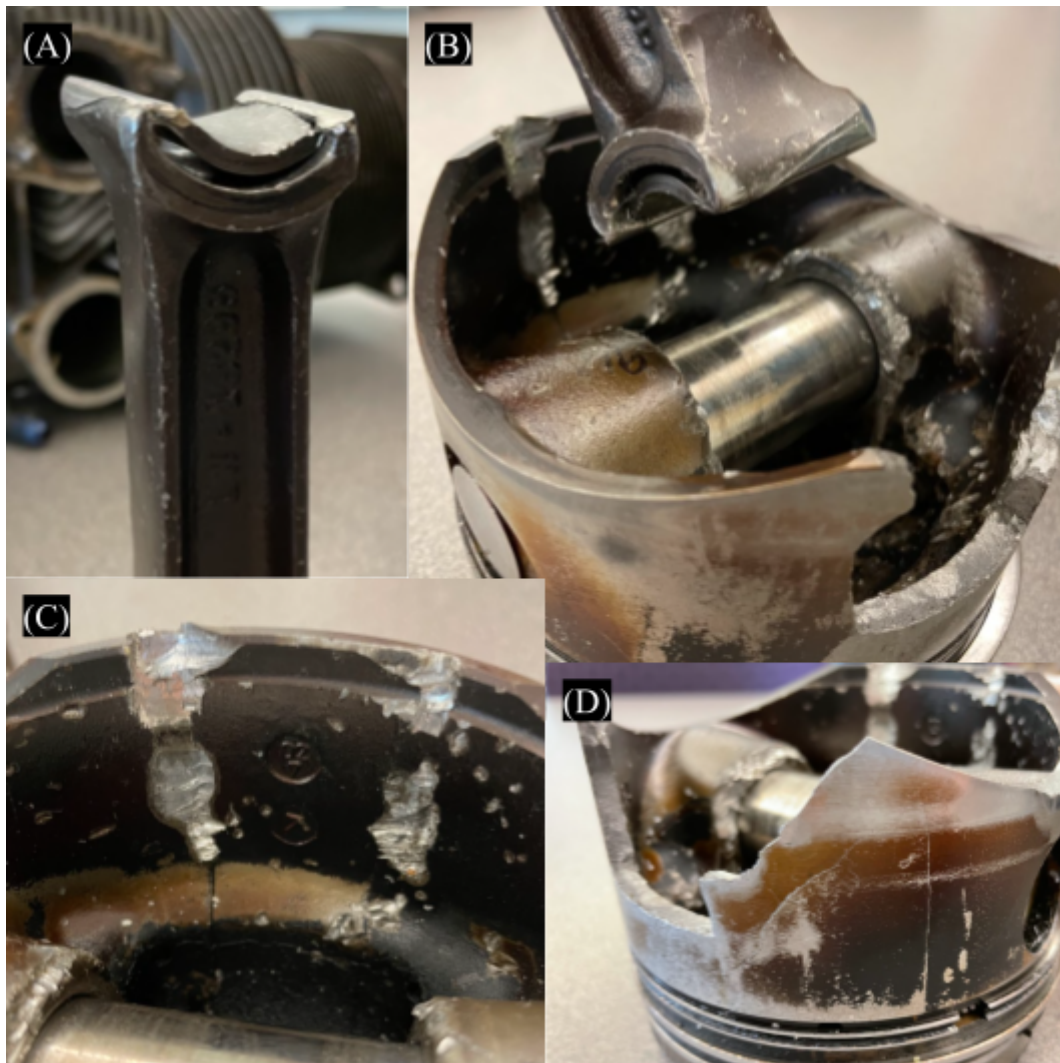
Figure 2. The disfigurement of each part can clearly be seen, as if a fragmentation grenade exploded, scarring the interior of the piston and connecting rod. (A) This is a picture of the ductile deformation of the connecting rod. (B) The connecting rod is fitted to the piston, which is missing a large section of material. (C) Evidence of shrapnel impact inside the piston walls. (D) Brittle crack propagation and trails are visible.

The team quickly theorized the origin of failure was the mate between the connecting rod and the piston. Unfortunately, as the connecting rod was detached, it was also repeatedly struck into the piston shaft. This bent the head of the rod into an unusual shape. The original fracture surface and initial site of crack propagation were mangled and trapped by this metal warpage. Therefore, in order to access the critical surfaces (which would be the interior of the connecting rod head), the team put together a cutting plan. This would isolate each surface in a manner that would allow optical and scanning electron microscopy. Two cuts were to be done. The first to separate the head from the rest of the rod with the aid of a high speed diamond saw. The second to open up the warped head and reveal the important surfaces under question utilizing a low speed precision diamond saw. Figure 3 presents the cutting plan for the connecting rod.

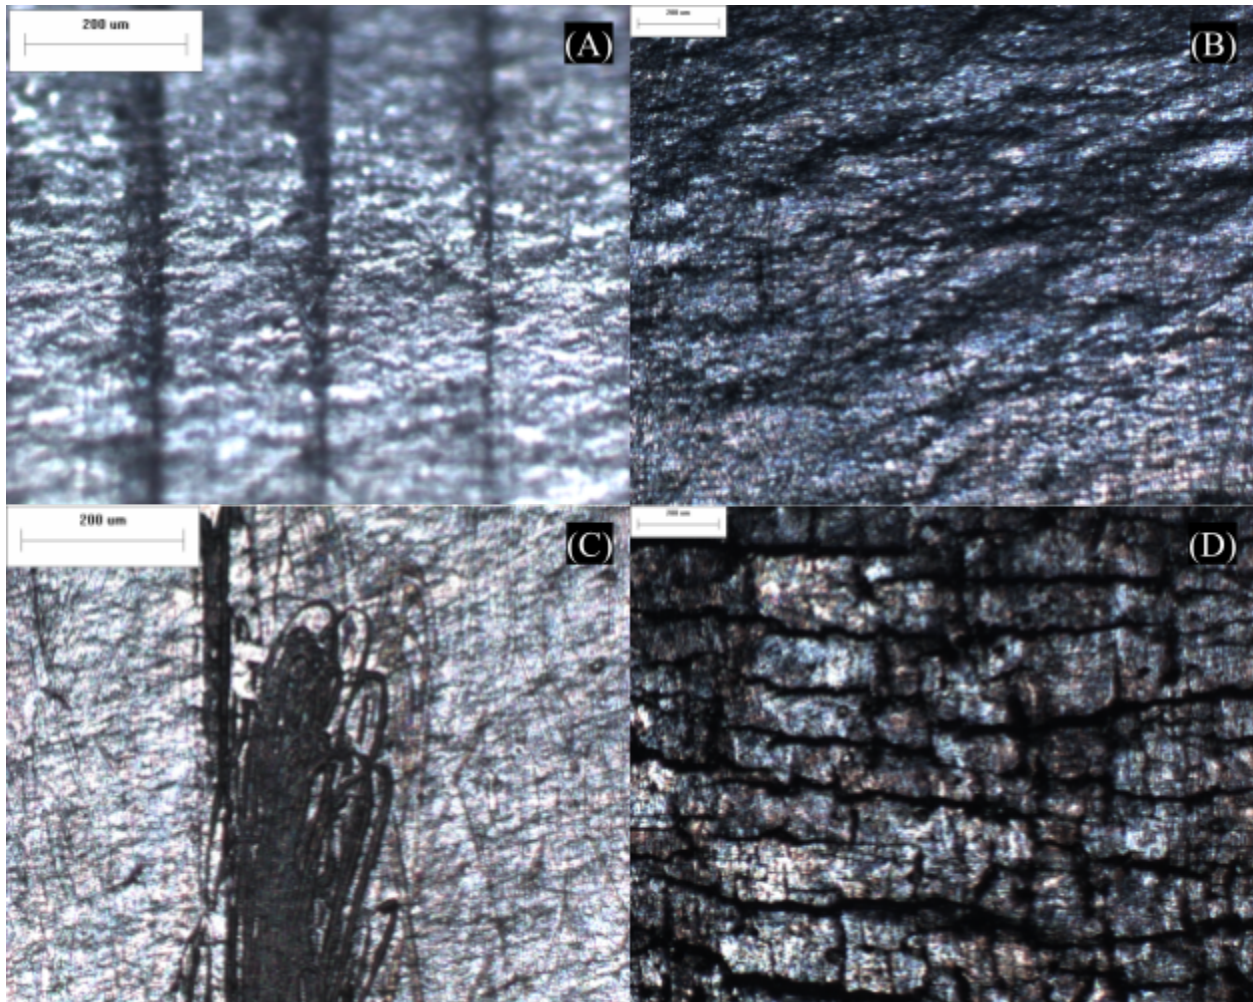
Figure 5. The above images are captures of the exposed connecting rod interior surface through Olympus brand optical lenses. Micron bars indicate the length of 200 microns. (A) This is the raw manufactured surface, clear machining marks can be seen precisely in line. (B) The machining marks have been worn away through stress and cracking. (C) Some kind of particle was causing cyclical abrasion, perhaps initiating the overall failure. (D) Mud-cracking is strong evidence of thermal wear due to high frictional environments.

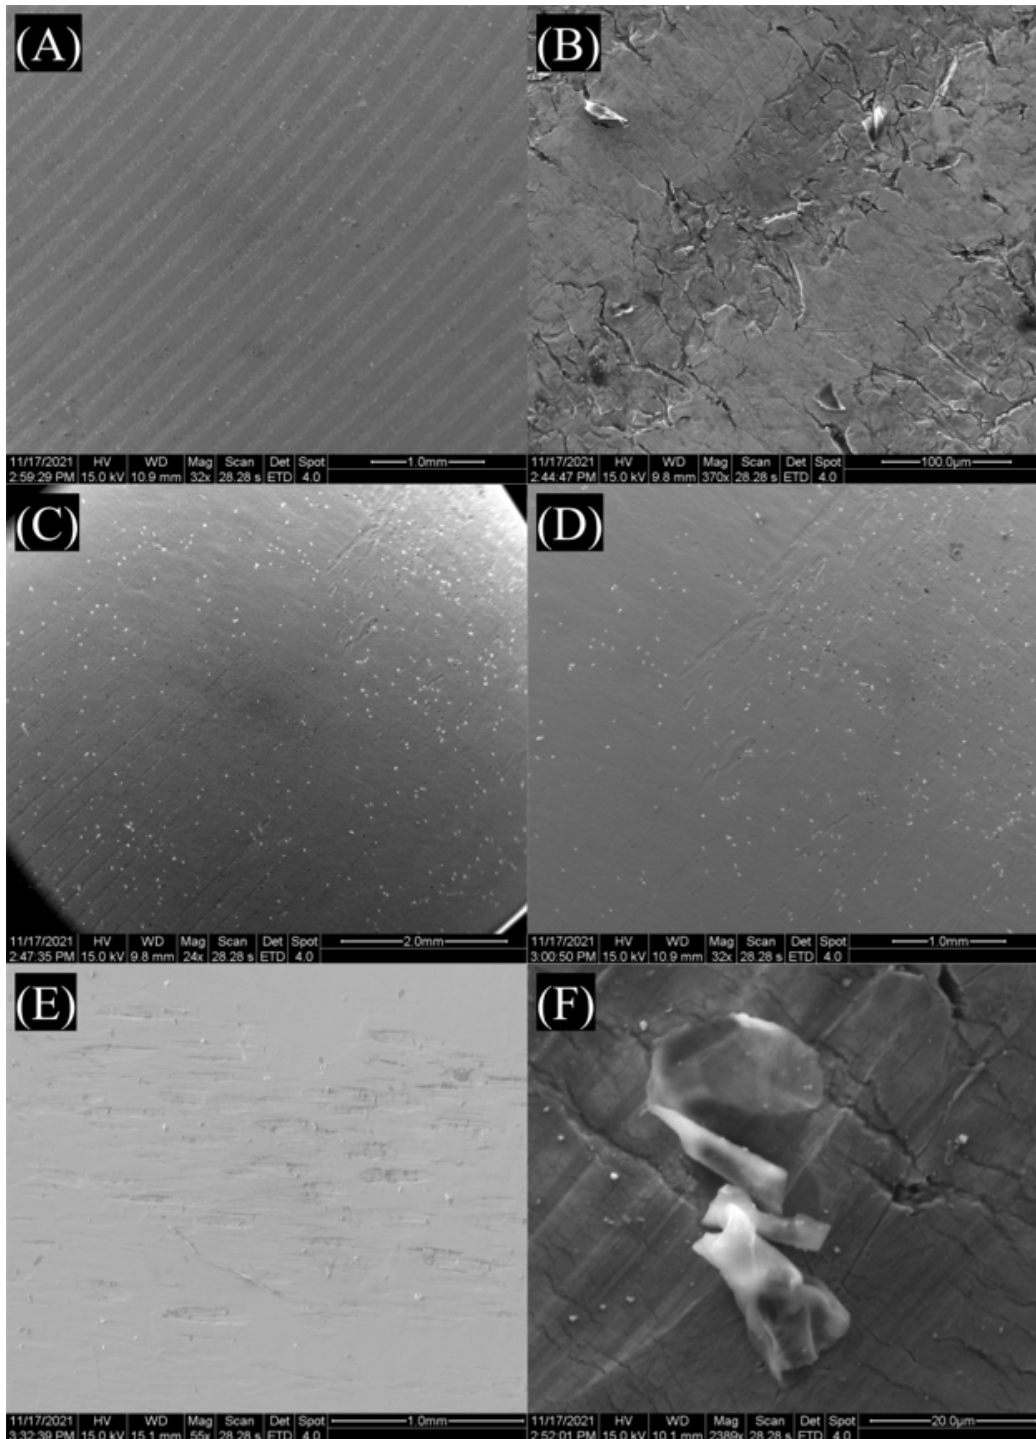
Figure 6. Scanning electron micrographs of the smaller split connecting rod piece. (A) This is how the surface is supposed to look, clear machining lines. (B) A closer look at machining lines. (C) The transition between a machined surface and a worn smoother surface. (D) The smooth almost polished surface is due to wear scatter with unknown bright particles. (E) Visible gouging and scraping are observed. (F) A magnified view of the bright particles on the surface.

The theory of failure via the bushing has evidence in observations made on the parts that are present. Comparing image A and image D from Figure 6 makes it clear that some areas of the interior of the connecting rod were worn and some had the original machining lines. This is evidence of the bushing rotating against the connecting rod, which is not how well designed bushings should act. Moreover, image D and F from Figure 6 show unknown particles embedded into the connecting rod interior surface. Additional techniques such as energy dispersive x-ray spectroscopy (EDS) could be performed on these particles to determine if they are bronze or some other material. The presence of bronze would give more evidence to wear between the bushing and the connecting rod. Beyond the micrograph evidence, there is also evidence of bushing failure in official Federal Aviation Administration (FAA) literature. Multiple uncontained engine failures similar to the one observed by the pilot in this case were reported to the Aircraft Owners & Pilots Association. The AOPA issued a letter to the FAA in August of 2017 arguing that Lycoming engines of the same make and model were failing due to non-conforming connecting rod bushings (Oord, 2017). As a result of this letter, the FAA issued an official Airworthiness Directive with accompanying mandatory service instructions requiring inspection and replacement of the bushing (Lycoming, 2020) (Ganley, 2017). Additional maintenance records may be able to identify the bushing that was installed in this particular engine and possibly find it to fall under these service instructions.

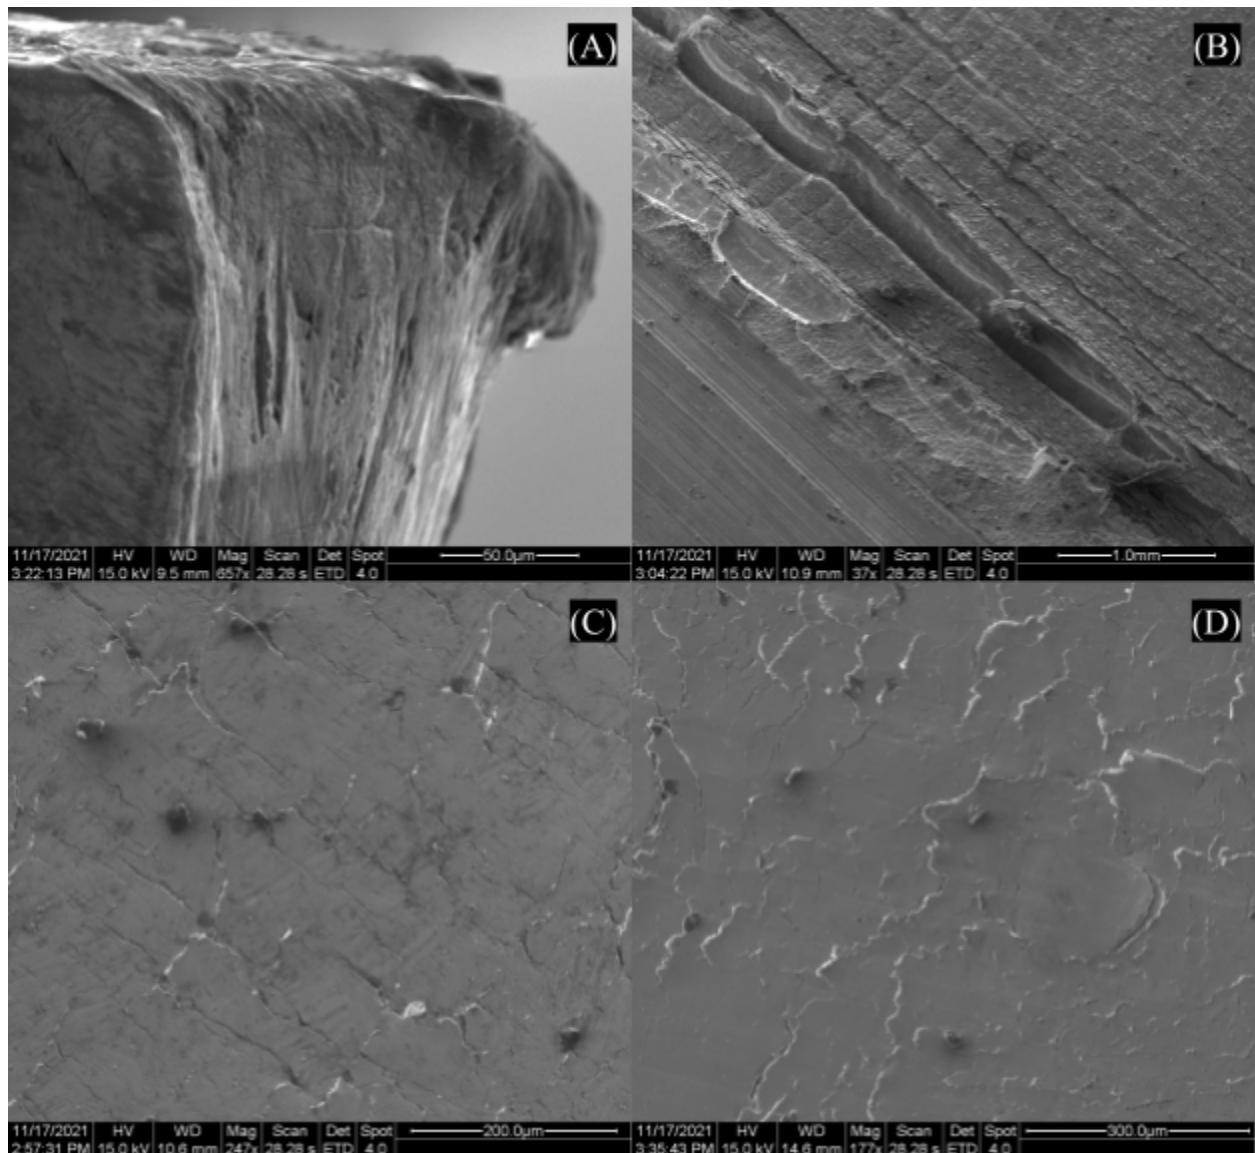
Figure 7. Scanning electron micrographs of the interior surface base piece of the split head connecting rod. (A) This could possibly be the crack initiation site, however, the tip is severely blunted due to cyclic ductile deformation. (B) Here is a primary canyon crack that developed due to high tensile stresses. (C) This is evidence that somewhat resembles mud-cracking. (D) A magnified image of a worn surface that seems to be slightly polished. No trail of machine lines remains which indicates some sort of unintended deformation resulting in a smooth finish.

After everything was disassembled and inspected to the best of the research group's ability, individual features can start to be connected to paint an overall picture. The first and most obvious possible failure mode that may explain the detachment of the connecting rod is that the connecting rod itself fractured. This theory of failure is substantiated first by the testimony of the pilot, who stated the moment of failure felt like a sudden jolting burst. This is consistent with a fast propagating brittle fracture, which is likely what is observed in Figure 7. The potential crack initiation site in Figure 7A would also support the idea that the connecting rod failed at the point of connection with the piston. However, this theory of failure cannot be confirmed, as the primary piece of evidence is missing, the original fracture surface. If the original fracture surface was intact, not so heavily deformed, and contaminated as seen in Figure 3, then more definitive evidence such as chevron lines or other microstructural features may have been observed.

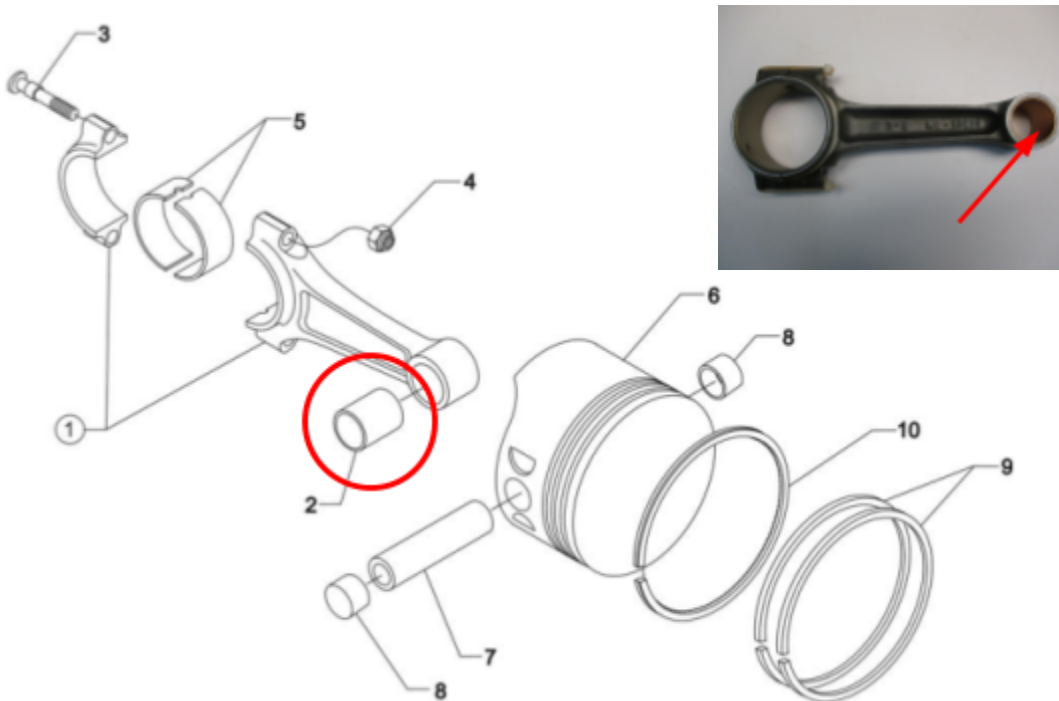
Figure 7. Lycoming O-235-N2C series 4 cycle engine connecting rod assembly exploded drawing. The bronze bushing is labeled with the number 2 (Lycoming, 2012, pp. 1-83).

The second theory of failure looks beyond what parts of the engine are present and instead eyes the assembly as a whole. A drawing of the complete engine connecting rod assembly is available from Lycoming and is shown below. When comparing the drawing to the parts present in Figure 1, it is clear the split-type bronze bushing that should be between the piston pin and the connecting rod is not present.

The evidence presented in this failure analysis is ultimately insufficient to confirm any one theory of failure. Separate pieces of evidence exist to support theories but ultimately due to how mangled the parts are from the violent fracture, no clear failure method can be confirmed. Evidence of the severity of this failure can be seen in the mud-cracked microstructure in image D of Figure 5. This type of microstructure is indicative of the extreme thermal conditions and deformation the part underwent during the failure event. Regardless of the exact failure mode, it is recommended that the connecting rod-bushing assembly be re-evaluated for design flaws.

Given all that has been presented, it is recommended that the connecting rod, bronze bushing specifications, and tolerances should be re-evaluated and further examined to gain a clear picture on what has happened in this instance of failure as well as to prevent future incidents.

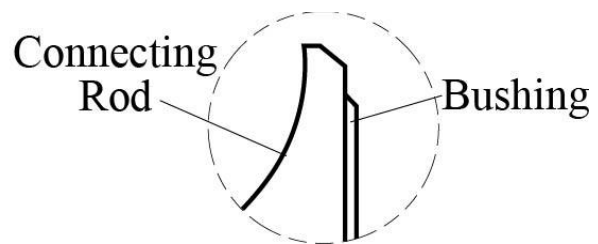
Figure 8
**Connecting Rod Bushing
Out of Place**

NOTICE: As the connecting rod bushing moves further out of place, the piston at the piston pin hole could show wear. If the connecting rod bushing is out of position, examine the piston for wear.
