Connector Rod Fracture & Failure Analysis in Airplane Engine of 1979 Cessna-152 N49681

MATE - 450 - 01 / 02
Professor Ryan T. Smith

California Polytechnic State University, San Luis Obispo
Department of Materials Science & Engineering

December 8, 2021

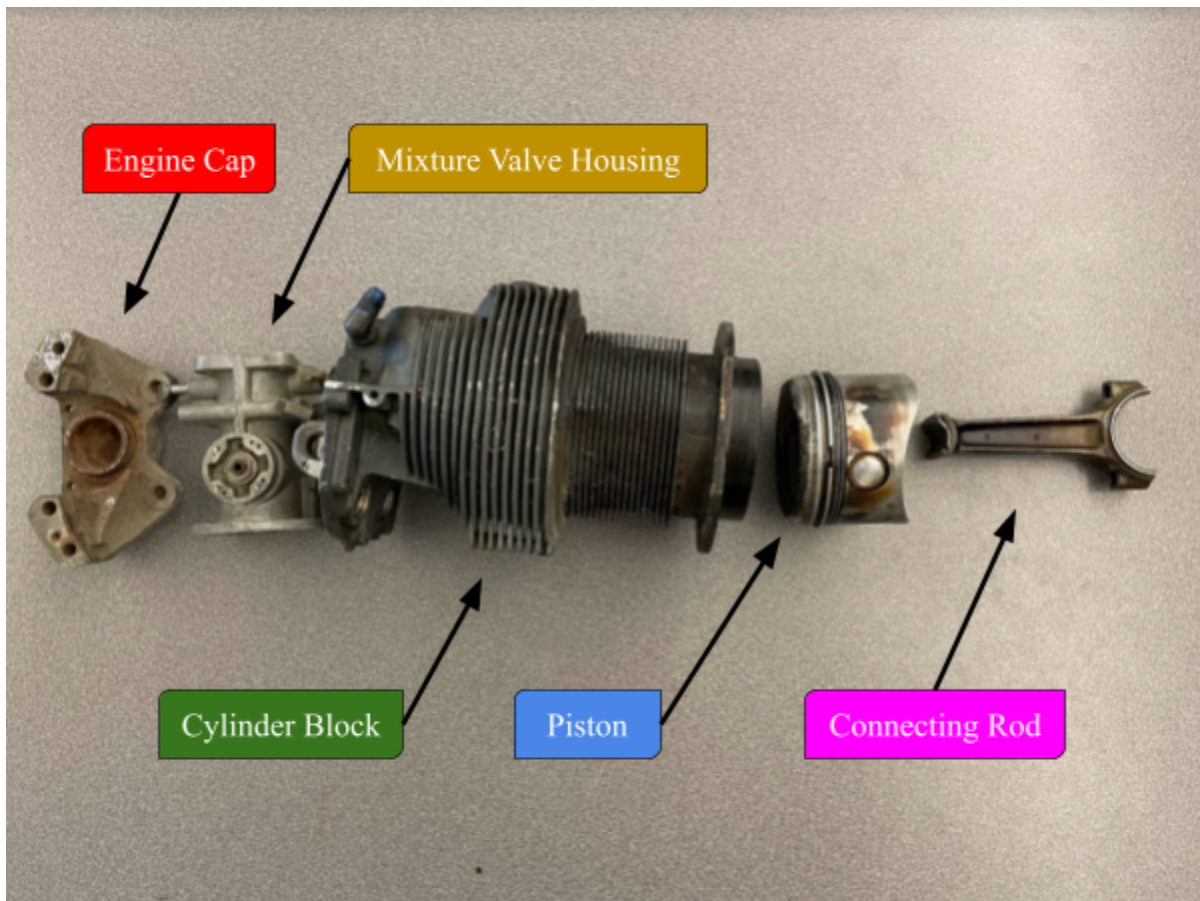
Figure 1. Displayed above is the full layout of all the available engine parts.

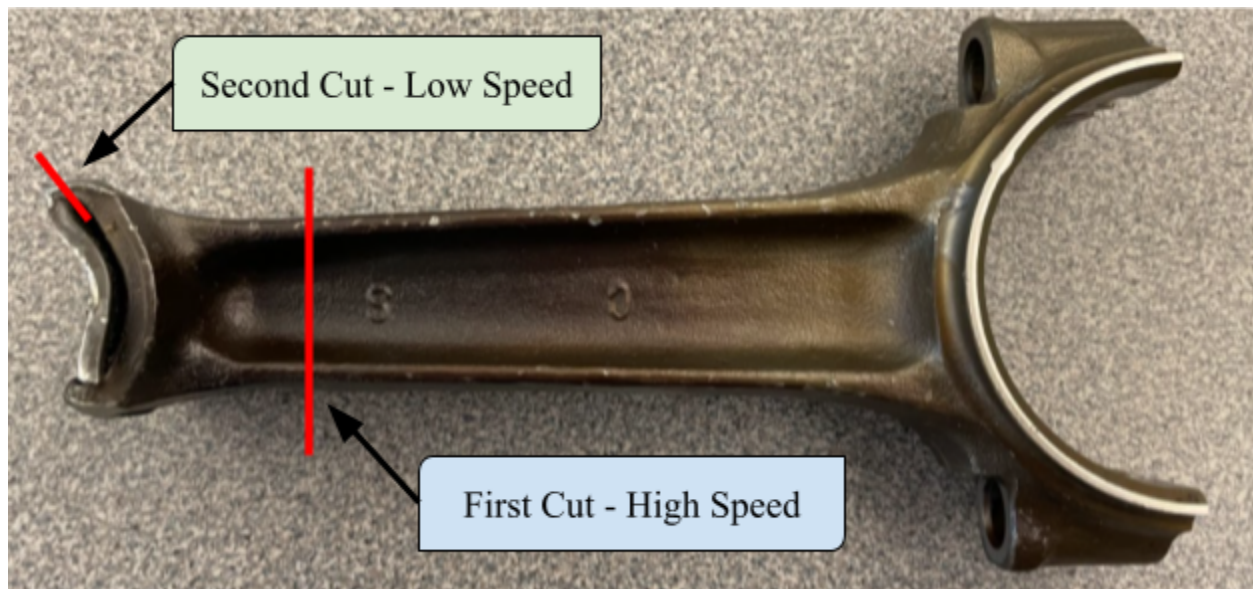
The team quickly theorized the origin of failure was the mate between the connecting rod and the piston. Unfortunately, as the connecting rod was detached, it was also repeatedly struck into the piston shaft. This bent the head of the rod into an unusual shape. The original fracture surface and initial site of crack propagation were mangled and trapped by this metal warpage. Therefore, in order to access the critical surfaces (which would be the interior of the connecting rod head), the team put together a cutting plan. This would isolate each surface in a manner that would allow optical and scanning electron microscopy. Two cuts were to be done. The first to separate the head from the rest of the rod with the aid of a high speed diamond saw. The second to open up the warped head and reveal the important surfaces under question utilizing a low speed precision diamond saw. Figure 3 presents the cutting plan for the connecting rod.

Figure 3. The connecting rod was subject to two cuts. The first cut was made in a high speed diamond saw to isolate the end of the connecting rod where the fracture and significant deformation occurred. The second cut was made in a low speed precision saw. This cut revealed the delicate and intimate surfaces under question.

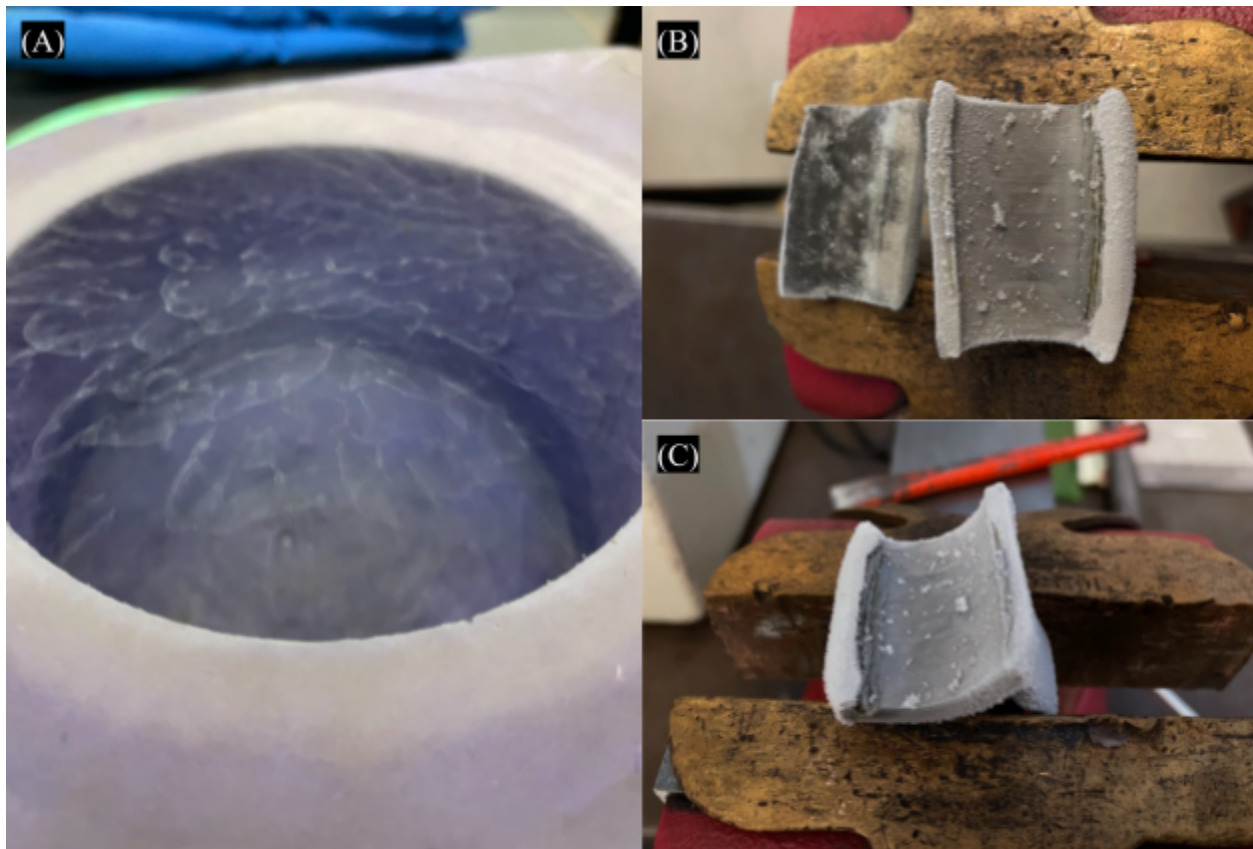
Figure 4. The effects of the ductile to brittle fracture temperature can be seen above. (A) This is a pool of liquid nitrogen with vapor forming at the surface generating a silky look. (B) The connecting rod split into two pieces to reveal the interior surfaces. (C) Another angle of the larger piece of the connecting rod head still inserted in the vice jaws.

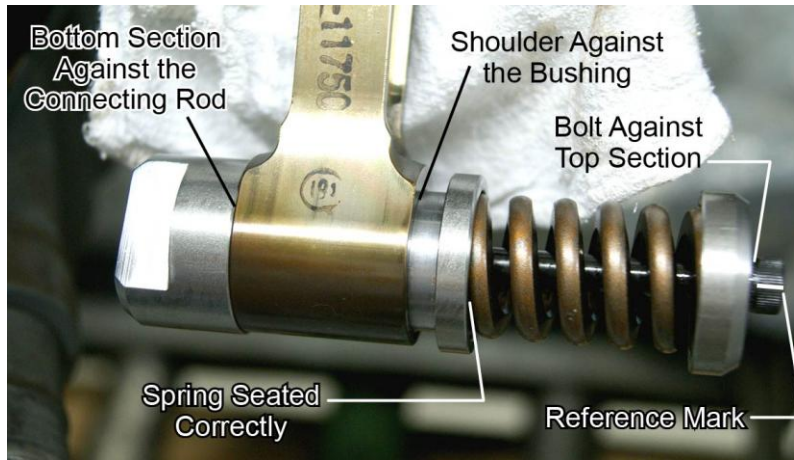
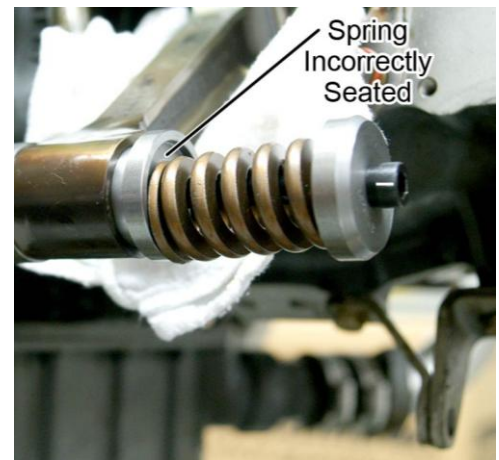
- The bottom section of the tool is in contact with the connecting rod
- The shoulder of the center section of the tool is in contact with the connecting rod bushing
- The head of the bolt is in contact with the top section of the tool
- The spring is seated correctly in the tool as shown in Figure 7. Figure 8 shows **incorrect** seating of the spring.

ST-531 Correctly Installed in the Connecting Rod

Spring Incorrectly Seated in the Tool

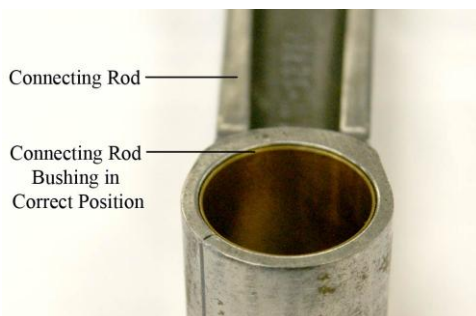
Figure 4

Example of Connecting Rod Bushing in Correct Position

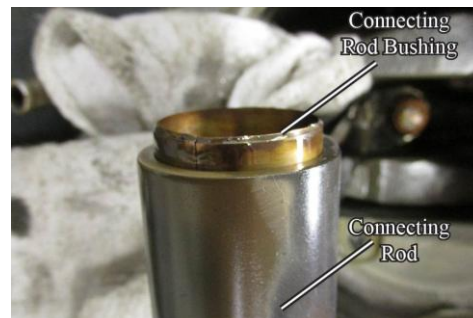
Figure 5

Example of Connecting Rod Bushing Raised Above the Connecting Rod

(b) If the sum total of the measurements from both sides of the connecting rod is greater than 0.038 in. (0.965 mm) (it is an indication the connecting rod bushing is loose or has moved or is out of place) (Figure 5). Remove, discard, and replace the connecting rod bushing.

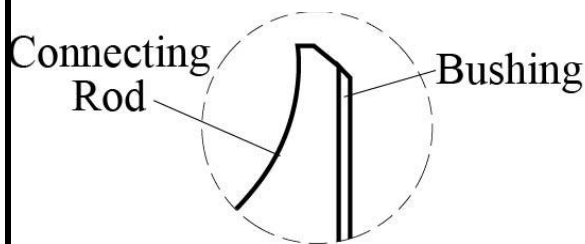
Figure 7
**Connecting Rod Bushing
in Correct Position**

(1) If the chamfer of the connecting rod and the chamfer of the connecting rod bushing align (Figure 7), this feature is acceptable. Go to Step 2 on the next page.

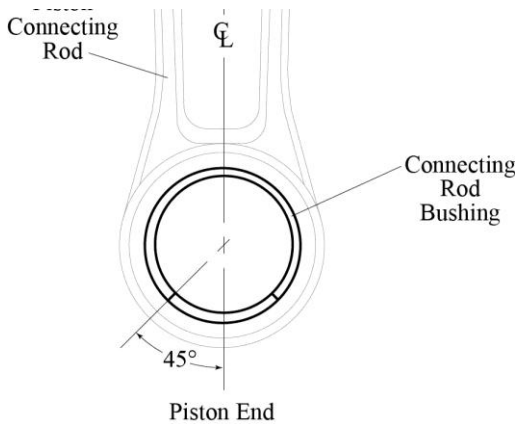
Figure 9

NOTICE: Connecting rod bushings are manufactured with a split line in the bushing. When installed, the split line of the bushing is positioned approximately at a 45° angle from the center line of the connecting rod as shown in Figure 9.

If the split line is visible at any other location other than approximately at a 45° angle from the center line of the connecting rod, the connecting rod bushing has moved and must be removed, discarded, and replaced.

Connecting Rod Bushing Split Line Position
